# Gentle Logging System Evaluation

(QUANTITATIVE MEASUREMENTS REPORT)

**Published by**  
**Michigan State University**  
**Upper Peninsula Tree Improvement Center**  
**Escanaba, Michigan**

## **Gentle Logging System Evaluation QUANTITATIVE MEASUREMENTS REPORT**

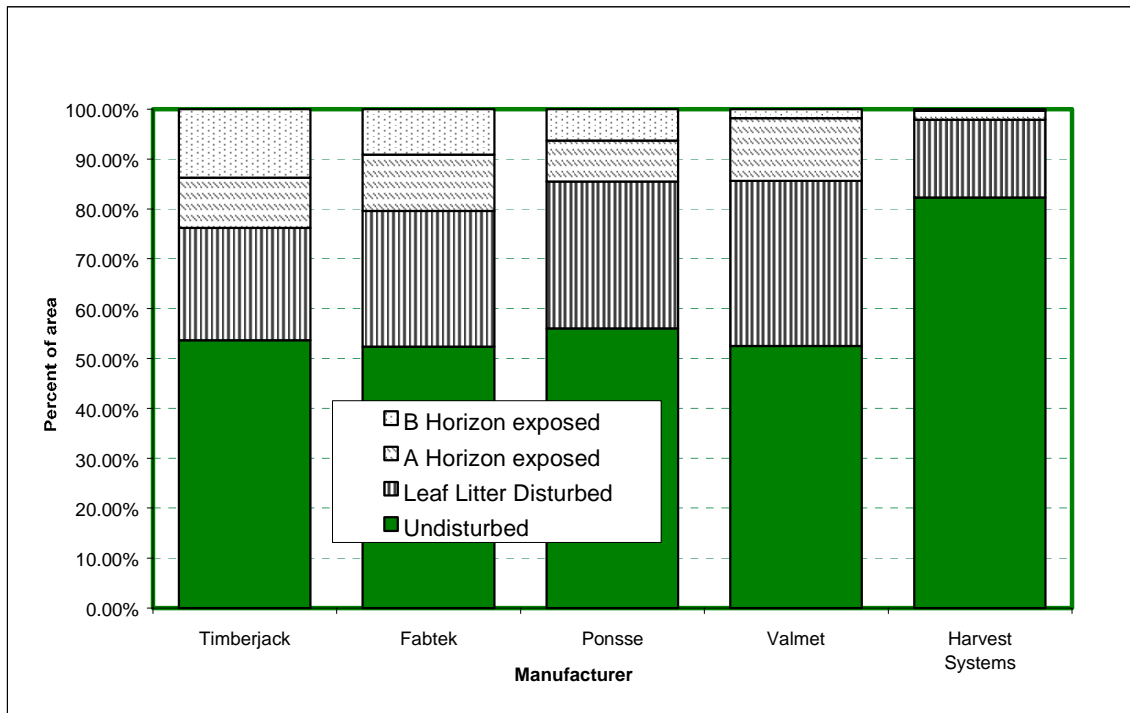
Figure 1. Extent of ground disturbance in harvested areas.

Compaction and rutting in skid trails was measured and will be described later, but this portion of the assessment was designed to describe the extent of soil disturbance from these harvesting and forwarding operations. Transects running perpendicular to the main axis of machine movement were randomly established in each harvesting area. Transects ranged from 550’ to 930’ long and were 10’ wide. Ground disturbance was scored throughout each transect using 5’ x 5’ square plots. Soil in these plots was classified as: (a) not disturbed, (b) leaf litter disturbed, (c) surface soil in the A horizon exposed, or (d) sub-soil in the B horizon exposed. Observers were told to look for signs that the machine had passed through the plots, so the presence of ruts (at least 2” deep) was also noted for each plot. These data were summarized and are presented in both Table 6 and Figure 1.

76% to 98% of the ground within each harvesting area was either undisturbed or merely had the litter layer disturbed. The systems with articulated harvesters disturbed 14% to 15% of the ground while the systems with

heavy skid-steer harvesters disturbed 20% to 24% of the ground. The latter type of equipment appears to have caused more disturbance of the A horizon as well. This was expected from machinery that scuffs the ground while turning. The smallest machine disturbed the least amount of the site (2%) but it only harvested 40% of the marked trees and these were not forwarded from the area.

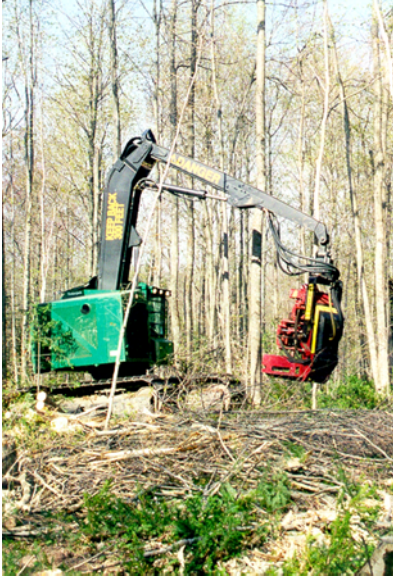
Figure 4. Timberjack 608s Harvester

System Description	Manufacturer	Harvester	Forwarder*
Tracked harvester and 6-wheeled forwarder	Timberjack	608s, 25' articulated boom (Figure 4)	1010, 6-wheeled (Figure 5)
Tracked harvester and 6-wheeled forwarder	Fabtek	FT133, 21' articulated boom (Figure 6)	FT346b, 6-wheeled (Figure 7)
6-wheeled harvester and 8-wheeled forwarder	Ponsse	Ergo, 33' telescopic boom (Figure 8)	Caribou, 8-wheeled (Figure 9)
	Valmet	911.1, 32' telescopic boom (Figure 10)	840, 8-wheeled (Figure 11)
Small, tracked harvester with no forwarding	"Harvest Systems"	Link-Belt LS1600, 21' articulated boom, (Figure 12)	NONE
* - all forwarders were equipped with Olofsfors Eco-tracks (Figure 13)

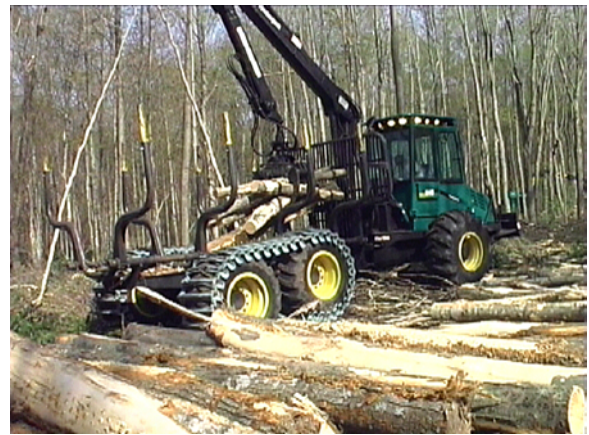
Figure 5. Timberjack 1010 Forwarder

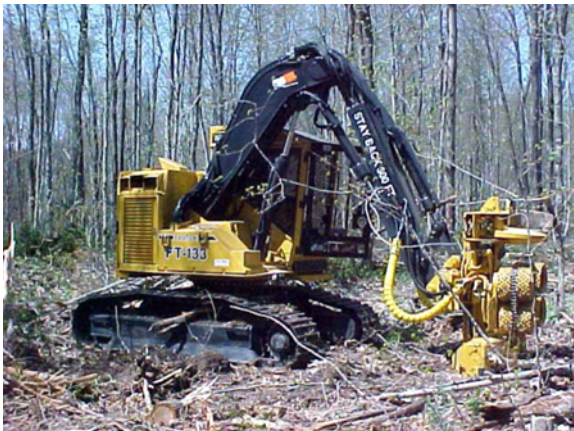
Figure 6. Fabtek FT133 Processor

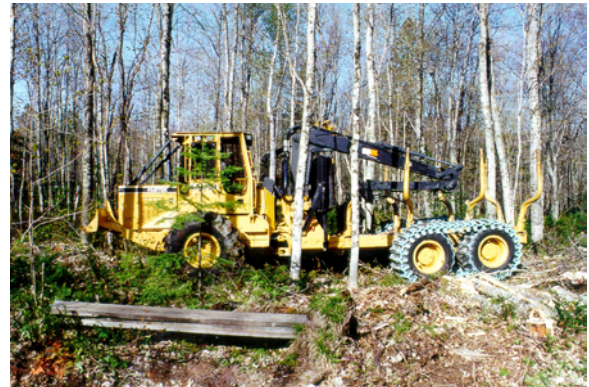
Figure 7. Fabtek FT346b Forwarder

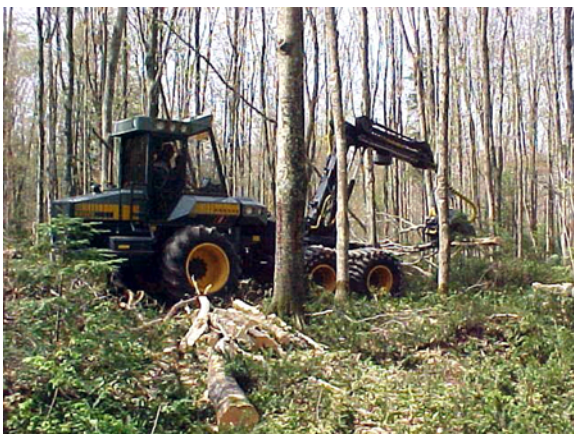
Figure 8. Ponsse Ergo Harvester

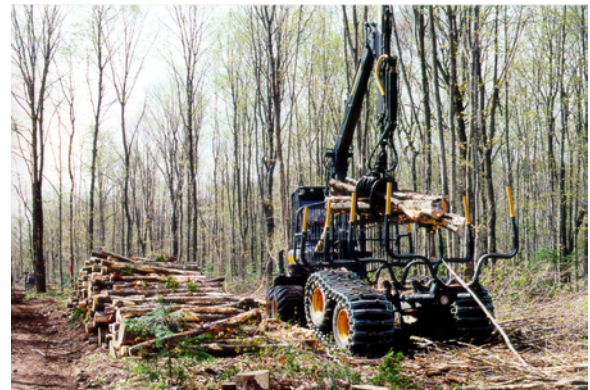
Figure 9. Ponsse Caribou Forwarder

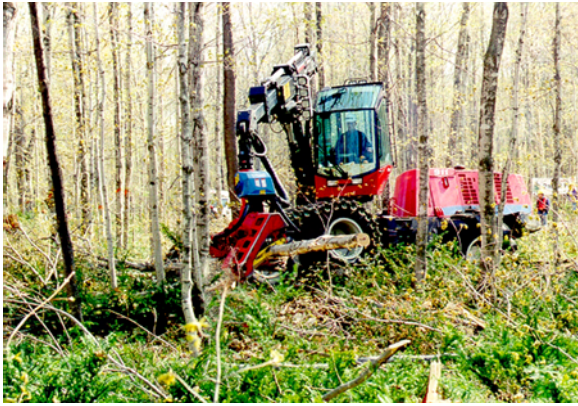
Figure 10. Valmet 911.1 Harvester

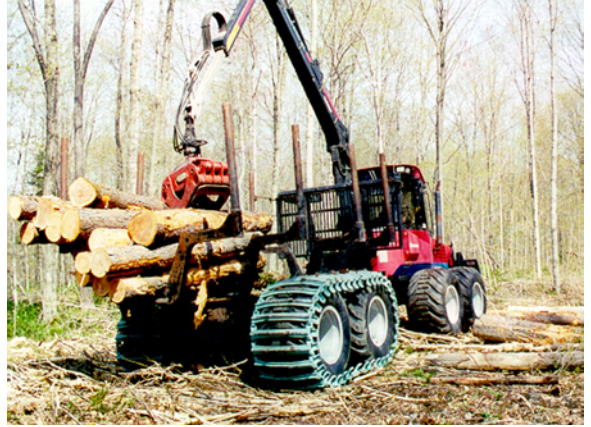
Figure 11. Valmet 840 Forwarder

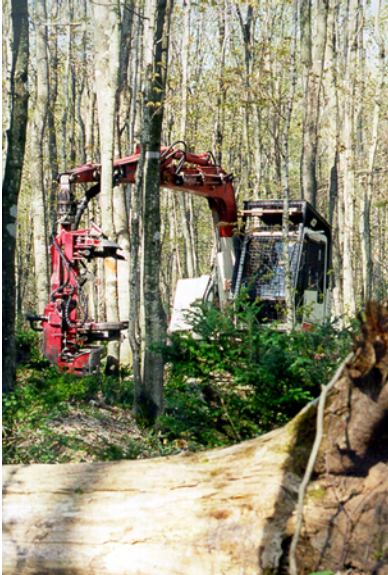
Figure 12. "Harvest Systems"

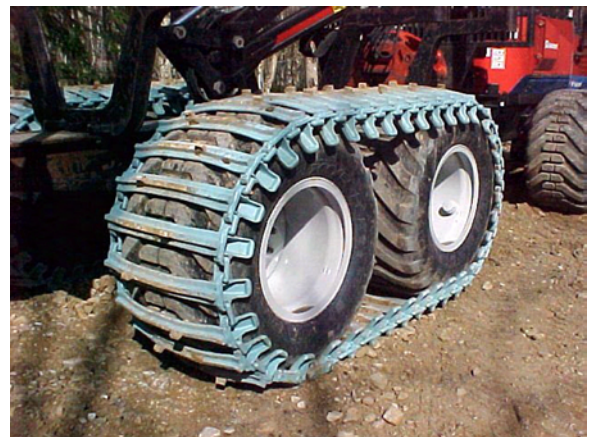
Figure 13. Olofsfors Eco-Tracks
