Ensuring Ice Cream Quality Through Palletization Management (Under NDA)

Kate Heinecke, Kealey Kolp, Summer Luick, & Carter Ostrowski

Client: Tillamook Faculty Advisor: Dr. Kirk Dolan

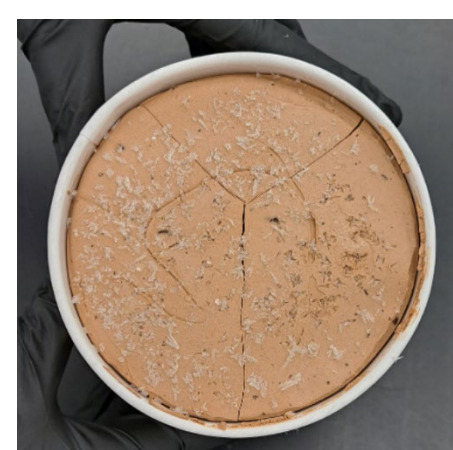
Figure 2: Ice crystal formation

- The pallet stacking area is not temperature controlled and can reach up to 70 °F in the summer
- Minimal stabilizers increases the ice cream's susceptibility to melting
- Temperature abuse causes ice crystal formation and shrinkage of their ice cream displayed in figure 2 and figure 3.

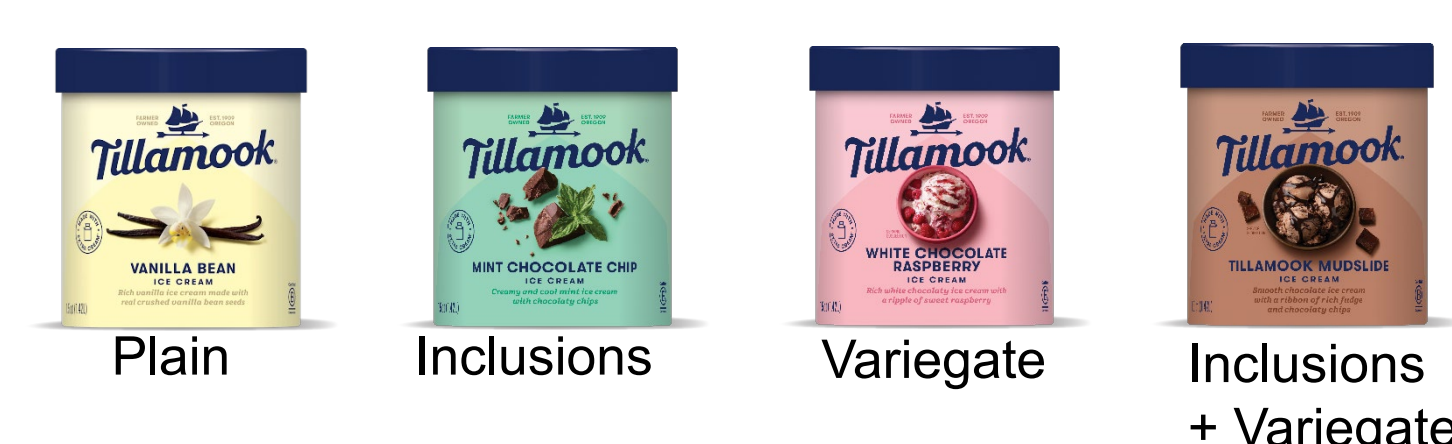
Figure 4: Ice cream subcategories

Tillamook produces four subcategories of ice cream displayed in figure 4.

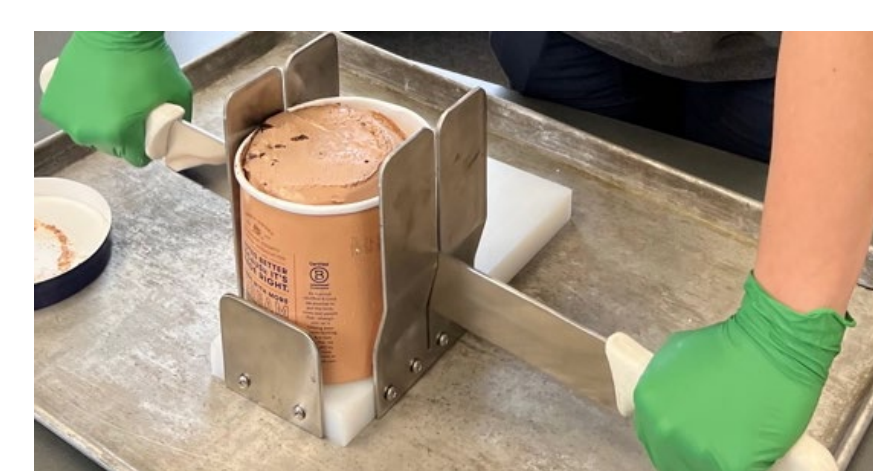
Figure 4: Ice cream cutting to identify inclusions, variegate, and sensory attributes

Ice cream quality is monitored throughout production using periodic ice cream cuttings shown in figure 5. The ice cream is evaluated on a pass, fail, warn system.

- Pass: No defects, continue production
- Warn: Minor defects, investigate cause
- Fail: Major defects, product not released
